# BELZONA SEALS AND REINFORCES THE BOTTOM OF A HYDROCARBON STORAGE TANK.

ID: 9016

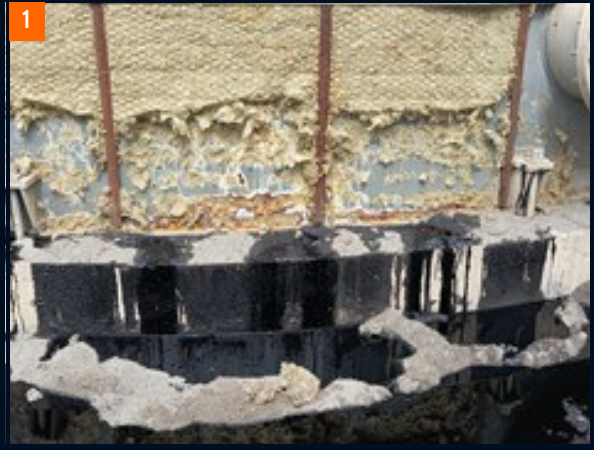
The bottom of a hydrocarbon storage tank had corroded over time, leading to a continuous leak between the tank and its base.

1. Live hydrocarbon leak.
2. Leak sealing between tank bottom and base.
3. Plate bond reinforcement on the lower part of the tank.
4. Application du Belzona 5811 to protect the plate bond against the environment.

The multiples leaks were firstly sealed using Belzona 9611. Belzona 1511 was then used to seal between tank bottom and base prior to the plate reinforcement on tank where wall thickness losses are significant. The coatings Belzona 1391T and Belzona 5811 were applied to the concrete based and plates in order protect them against the open air environment. The application was carried out in accordance with a modified version of Belzona System Leaflet TCC-05.
