# SEALING OF THE HIGH SCHOOL ORCHESTRA PIT

ID: 9025

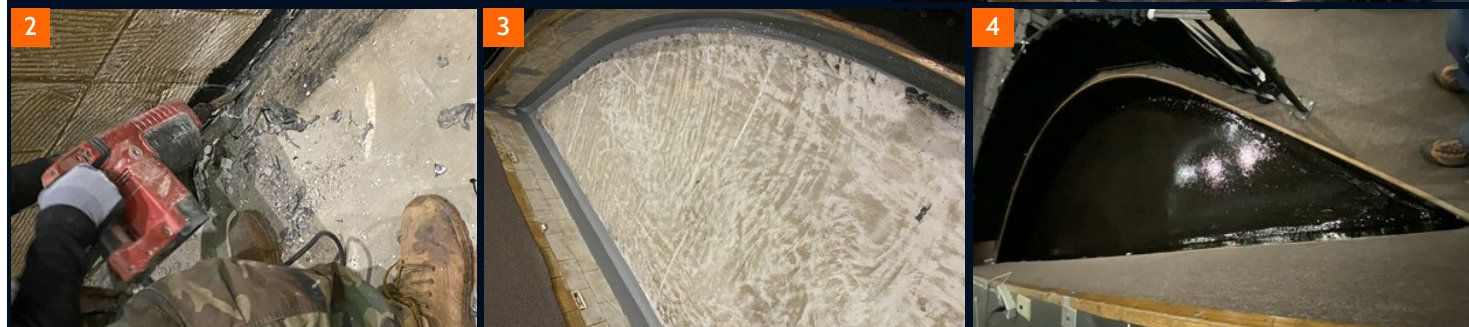
Local High School was experiencing ground water seepage into their Orchestra pit. As a result, all practices were postponed indefinitely until the pit was repaired.

1. Damage area
2. Preparing the surface
3. 4111 and 3121 application
4. 5811 top coat was applied

Old repairs were removed with the use of hand tools. Cove was build using Belzona 4111 and then sealed with Belzona 3121. Two-coat system of Belzona 5811 was then applied to entire orchestra pit.
