# BELZONA MAKES 50 YEAR OLD SAND FILTER PUMPS FEEL YOUNG AGAIN

ID: 9027

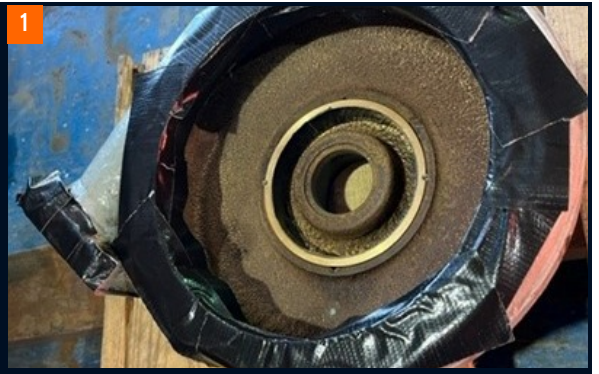
1. Casing showing signs of extreme erosion from years of sandy water service.
2. Backing Plate showing signs of extreme erosion from years of sandy water service.
3. Freshly rebuilt and coated casing ready for more years of service.
4. Backing plate feeling young again after being rebuilt and coated.

The pumps were brought to the shop, de-salted, blasted to above a 3-mil average, rebuilt with 1311 and coated with two coats of 1331.
