# ACID CONTAINMENT FLOOR RE-HAB WITH BELZONA

ID: 903

Floor and sump access-way in water treatment plant.

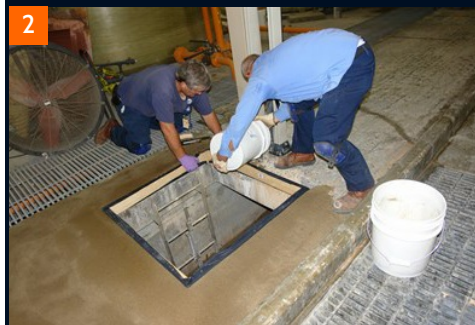
1. Floor prepared for re-surfacing
2. Re-shaping the access opening  
Belzona 5811
3. Grey coat over beige with Surefoot added
4. Rebuilt, protected, a first class job!

Application was carried out in accordance with Belzona Know-How System Leaflets FPA-1 & 3. Bulkfill was used to rebuild the sump access and spalled areas. The entire area was then given two coats of Immersion Grade with Surefoot Aggregate applied to achieve safe footing.
