# BELZONA BEEFS UP ROCK BOX WEAR PAD

ID: 9030

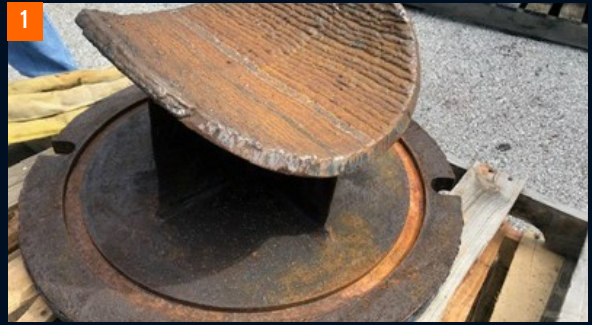
Weld overlay wasn't enough for the wear pads of this dredging rock box. This wear pad will see anything from mud, sand, oysters, rocks, dropped tools in the bottom of the ship channel, and many other hard objects picked up by the dredging pump.

1. Wear Plate Before
2. Priming coat of Belzona 1331
3. Finished coat of Belzona 1814
