# EMERGENCY FLOOR REPAIR WITH BELZONA 4111

ID: 9031

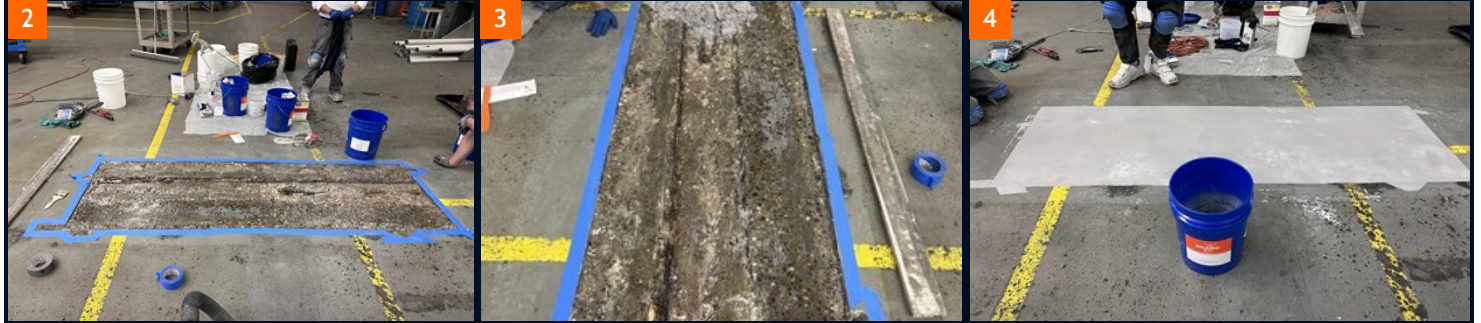
## PHOTOS

Designated walkway was heavily damaged over the years. Previous repairs had failed and the client was faced with safety violations. Traditional concrete was unable to withstand the chemicals and heavy traffic.

1. Area to be repaired
2. Repair area defined, sawcut and excavated 4911 Surface Conditioner Applied
3. 4111 Being Applied
4. Finished Application

Customer needed a quick turnaround to accommodate the next days shift. The floor was suffering from daily chemical contact that had worked through the previous coating and into the concrete. 4111 was selected for the quick turnaround and chemical resistance. The repair was completed with four and a half kits of 4111 in 3 hrs. No delays for the next days production.

Area was sawcut to a minimum of 0.25". Low spots were up to 3" deep and exposed rebar was prepped using a Bristle Blaster. A chipping hammer was used to remove break up the sections that were well adhered.
