# BELZONA 5851 HELPS AVOIDS SHUT DOWN

ID: 904

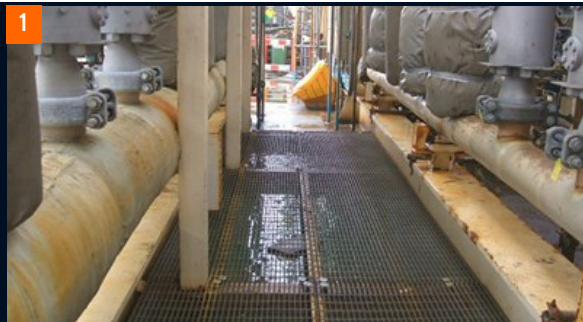
The loss of the original paint system exposed the pipe work to a risk of stress corrosion cracking whenever the fire protection Deluge system were tested.

Weathering of the original paint system on high temperature Duplex lines.

1. Manifold showing weathering of paintwork
2. Belzona 5851 applied to exposed pipe work
3. Belzona 5851 applied to exposed pipe work
4. Belzona 5851 applied to the manifold

Application carried out in accordance with modified Belzona System Leaflet VPF-2. The pipe- work was wet-blasted to remove poorly adhering paintwork and any salts from the substrate.
