# BELZONA STOPPED PIPE LEAK

ID: 9040

## PROBLEM

There were a cooling water pipe with leaking holes

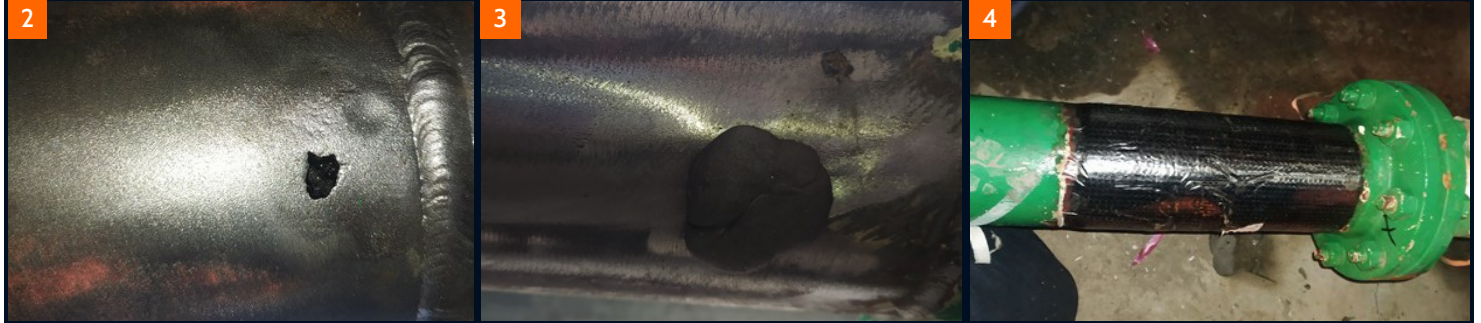
## PHOTOS

1. Leaking hole
2. Surface preparation
3. Stopped leaking
4. Strengthen pipe section

Surface preparation (MBX)

Cleaning (B9111)

Stop leaking (B9611)

Strengthen the pipe (SuperWrap II)
