# BELZONA 1341 KEEPS SWIMMING POOL RUNNING SMOOTH YEAR ROUND

ID: 9041

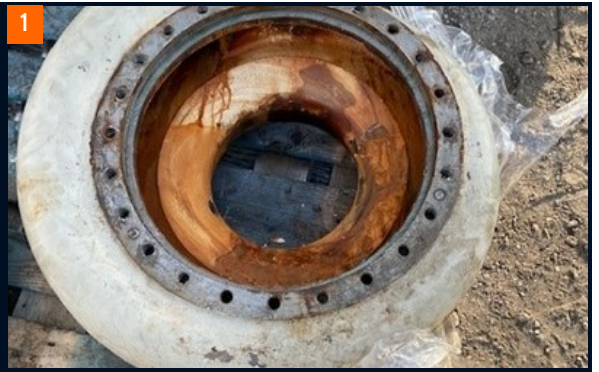
This pool water pump had erosion and corrosion issues from years of service in a wave pool. The client was given a choice between repair or replacement and looked to Belzona for a replacement solution.

1. Casing before coating showing wear from service
2. Pump plate before showing service wear
3. Freshly rebuilt and coated pump casing
4. Super smooth rebuilt and coating of Belzona 1341 to the pump plate

Pump was blasted to SP- 10  
Rebuilt with 1121  
2 coats of 1341
