# BELZONA 4311 CR1 PROTECTS BUNDS FROM CHEMICAL ATTACK

ID: 9045

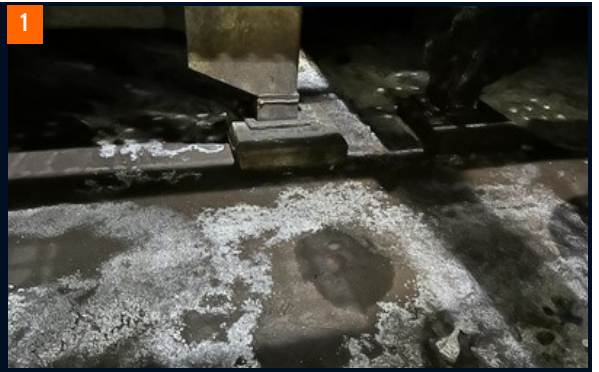
1. Confined access under the vats
2. Deep corrosion in areas of spillage
3. Belzona 4311 applied
4. The system can be applied around complex geometry seamlessly

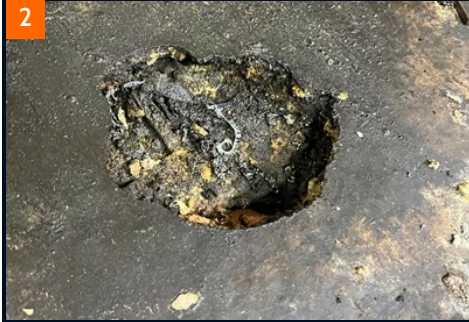
Several concrete bunds had been corroded by the aggressive chemicals used in the production process. A chemical resistant system was required to provide protection against the strong inorganic acids & alkalis used in the area.

The bunds were power washed to remove any chemical contamination. They were then abraded, Belzona 4911 TX Conditioner applied followed by two coats of Belzona 4311 CR1
