# GLASS LINED STEEL SHAFT REPAIR

ID: 9046

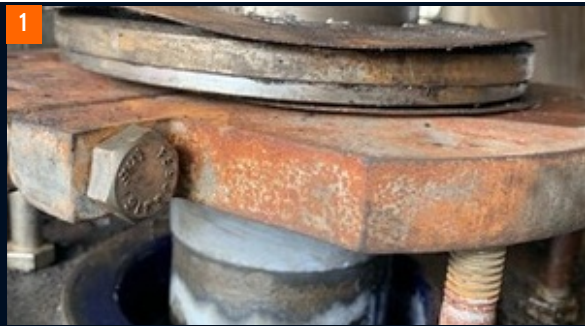
The customer had a glass lined carbon steel agitator that was inside of a reactor. The reactor contained Benzyl Chloride, Farmin DM2407N, A-95 and water. Maximum temperature was 300 deg F. As the agitator spun the bearing seal came loose, which caused the shaft to become damaged. The glass lined coating was removed and the carbon steel was gouged. The customer needed a quick efficient solution until the agitator could be replaced.

1. Close up on defect area of the shaft.
2. After surface preparation was completed on the defect area.
3. Shaft rebuilt with Belzona 1511 (high temperature paste grade system).
4. Belzona 1593 (high temperature coating) applied to seal the area.
