# REBUILD AND PROTECTION OF DISCHARGE ELBOWS ON A FRANCIS TURBINE

ID: 9047

The discharge elbows of Francis turbines suffered severe cavitation-erosion in the inferior areas.

Francis turbine elbows within a Hydroelectric Power Station.

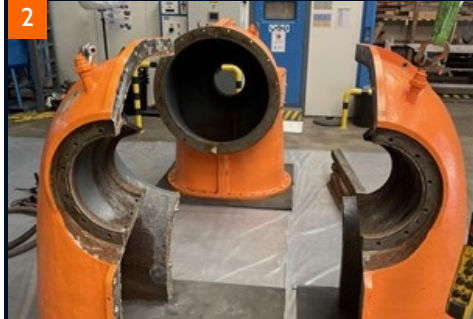
1. Damage caused by erosion-cavitation leading to a substrate loss greater than 5mm.
2. All elbows viewed together.
3. Post substrate rebuilding, the first coat of Belzona 1341 and Belzona 2141.
4. Final application showcasing Belzona 1431 and Belzona 2141.

The areas affected by cavitation were reloaded using Belzona 1311. All elbows were then coated using Belzona 1331 or Belzona 1341. The most cavitation-intense zones were then further top coated using Belzona 2141 (an Anti-Cavitation Resistant Elastomer). The application was carried out in accordance with Belzona System Leaflet VPF-01 & VPF-02.
