# PUMP CASING INTERNAL REPAIR

ID: 9049

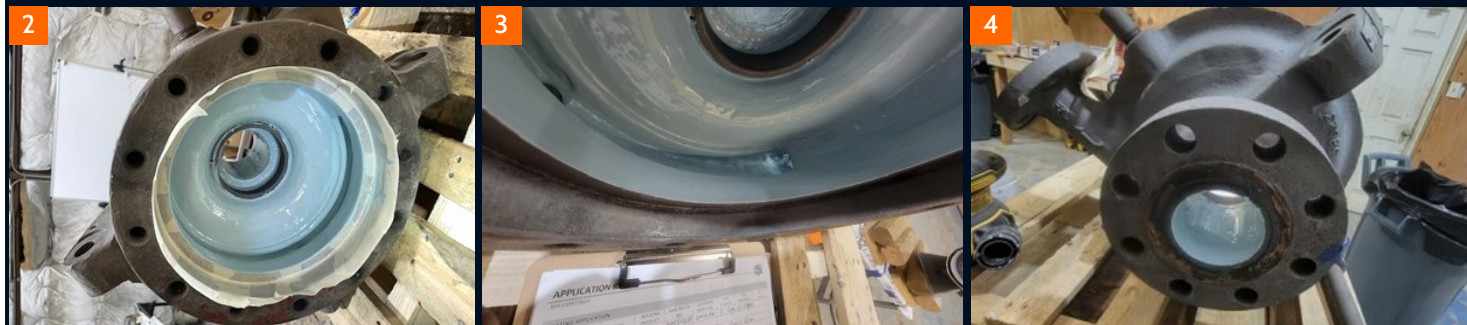
Customer had small through wall pin holes in the internals of a pump. Customer was facing a six month time before a new manufactured pump internal could be made and put into service. The issue may have been caused by corrosion or cavitation.

Three small 1/8" size through wall holes.

1. Pump internals after it was abrasive blasted. Two small holes shown.
2. Pump internals were coated with Belzona 1593.
3. Close up on patched area with coating over top.
4. Back side view of completed project.

1. We picked up the pump casing onsite of customer and brought it to our shop.
2. We complete surface preparation via vapor blasting, with emerald grit.
3. We patched the through wall defects by using Belzona 1511 and Belzona 9341 reinforcing mesh.
4. We applied a two coat system of Belzona 1593.
