# BELZONA COATING OF BYRON JACKSON SHIPPER PUMP

ID: 905

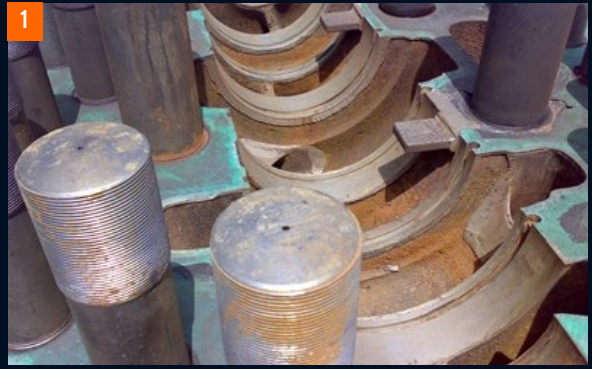
Erosion on the pump surface caused by sea water and sand inclusion during shipping operation.

1. Before blasting
2. After blasting with surface pitting evident
3. Rebuilding with Belzona 1311
4. Finished application with Belzona 1391

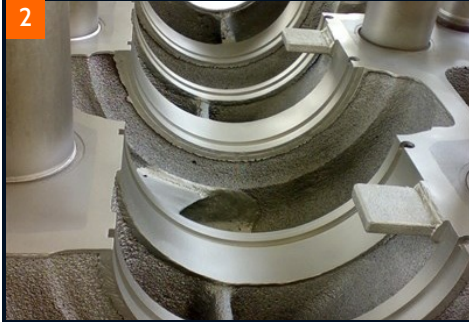
Erosion on surfaces of multi-stage pump.
