# REPAIR AND PROTECTION OF THE INTERMEDIATE & TAIL SHAFT OF THE BELEM SHIP.

ID: 9050

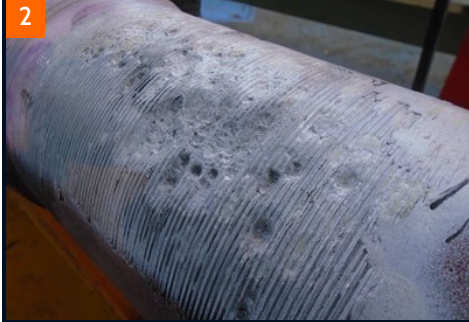
The propeller shaft showed heavy wear due to seawater corrosion.

1. The BELEM ship was first built in 1896.
2. The propeller shaft severely damaged by corrosion.
3. The propeller shaft was rebuilt using Belzona 1111 and the first coat of Belzona 5821.
4. Final application with the second coat of Belzona 5821 applied.

After grit-blasting and salt washing, reconstruction of the damaged propeller shaft was carried out using Belzona 1111. Two coats of Belzona 5821 were then applied to protect the shaft from future seawater corrosion. The application was carried out in accordance with Belzona System Leaflet SOS-06.
