# BELZONA REPAIRS TWO HYDROCYCLONES WITHIN A SUGAR REFINERY USING ALUMINA TILES.

ID: 9051

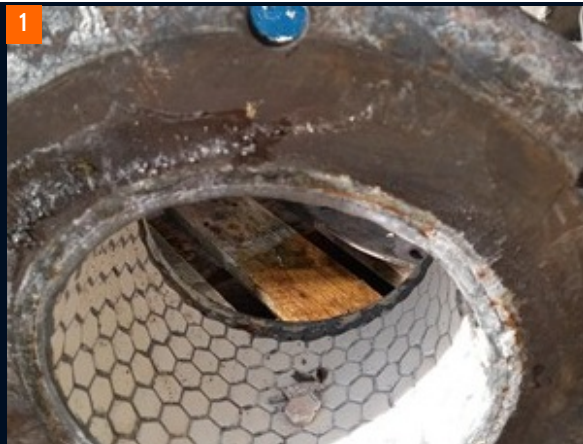
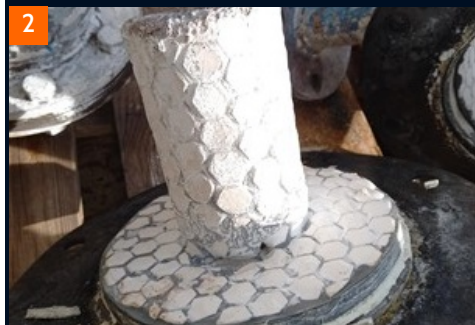
Two hydrocyclones were subjected to strong abrasion combined with a chemical attack (Milk of Lime;  $[\text{Ca}(\text{OH})_2]$ ). After 6-years of operation, a refurbishment was necessary.

1. Current system after 6-years of service.
2. Current system after 6-years of service.
3. During the repair procedure.
4. After the refurbishing works.

The substrate was first prepared, followed by bonding the Belzona 9811 alumina tiles using Belzona 1391 (remaining stock). Once the tiles were glued in place, the interstices were grouted using Belzona 1814. The application was carried out in accordance with Belzona System Leaflet VPF-02.
