# BELZONA SUPERWRAP II SECURES INTEGRITY OF PIPELINE

ID: 9054

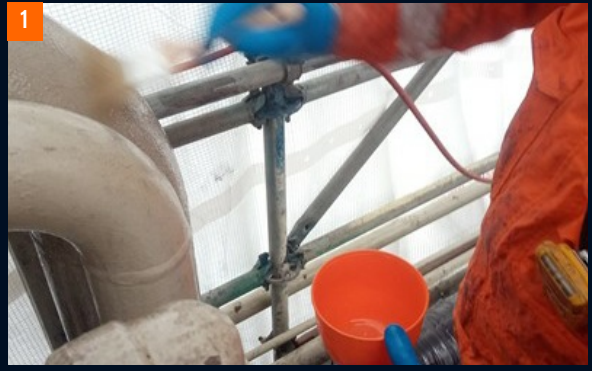
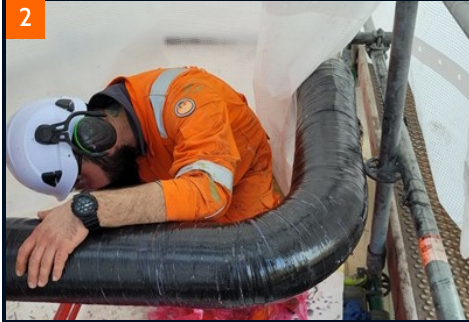
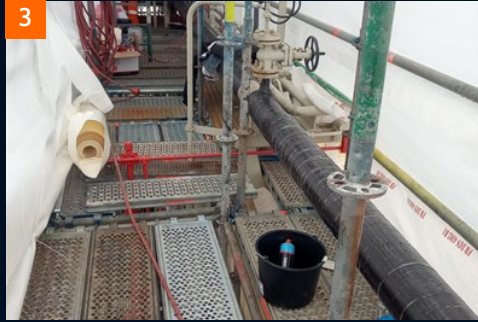
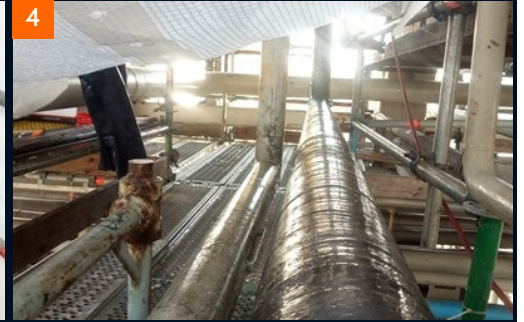
1. Surface preparation. A thin layer of Belzona 1983 onto the pipe.
2. After curing removing the Belzona 9382 tape to inspect the application
3. First 5 meters of Belzona SuperWrap completed. 35 meter to go.
4. Finished application halfway the pipe.

To bring strength back to this pipe we offered a Belzona SuperWrap II. No leaks were detected, so Belzona SuperWrap was applied directly on the hot pipe at 30 degrees Celcius. A small landing area was created on both ends of the wrap, so it would have a good adhesion. In total 3 layers were application on the straight parts and 6 layers on the corners.

At critical area's like support's and flanges the area was grinded with MBX Bristle Blaster. Also the landing area's (300 mm wide) were prepared with MBX Bristle Blasters (ATEX).

In total 30 meters of pipeline was wrapped by the Super Wrap II. The integrity of this pipeline is reassured without any downtime and production stop.
