# BELZONA REPAIRS WORN STAIRS IN A SCHOOL BUILT IN 1901

ID: 9056

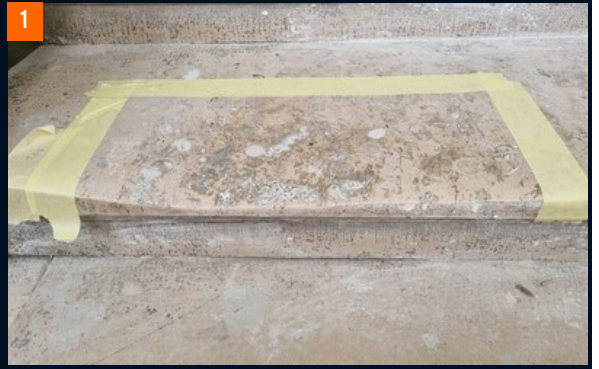
1. Loss of thickness on a stair due to 120 years of wear, represents a risk of falling and injury.
2. A stair rebuilt to its original level using Belzona 4111
3. A view on one of staircases in the school with several stairs repaired.
4. Situation after 8 months. We applied a final coat of Belzona 4151 with white stone dust and our customer abraded stairs in order to increase safety.

We installed a wooden support on front side of the stairs and then abraded the surface with electric grinders. Then we conditioned the surface with Belzona 4911 (using brush) and applied Belzona 4111 using a trowel. After full cure of Belzona 4111 we abraded surface once more and applied Belzona 4151 with addition of fine white dust in amount that produced color desired by customer.
