# BELZONA HELPS TO REFURBISH HISTORICAL WWII USS BOWFIN SUBMARINE

ID: 9057

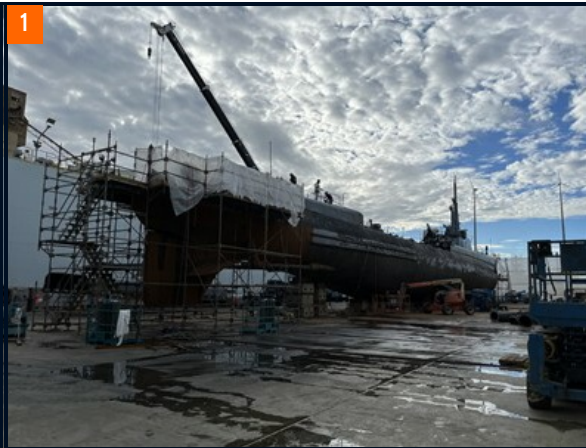
1. USS Bowfin on dry dock being refurbished.
2. Contractors applying Belzona 1121 across the pitted waterline of the entire hull of the submarine.
3. All of the pitted area filled with Belzona 1121 around the hull of the submarine.
4. The hull of the submarine being painted over after the Belzona 1121 was fully applied and cured. Application finished.

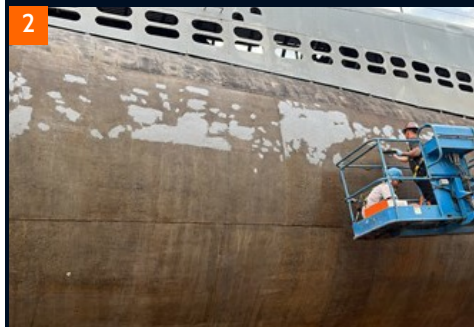
The USS Bowfin a Historical WWII Submarine had been situated in the Pearl Harbor Submarine Museum and Park since it was retired in 1971. After 20 years in the water since last dry dock visit it was finally brought back to dry dock for refurbishment. There was extensive and deep pitting of the submarine's hull down the waterline and had to be fixed/repared during the dry dock refurbishment.

Hull area was blasted to SSPC SP-10 cleanliness and a 3 mil profile. The repair area was clean with the proper solvent cleaner after blast. Belzona 1121 was applied in the critical pitted area that was identified. After the 1121 was fully cured the hull was painted with the specified product.
