# BELZONA REBUILDS WEAR RING SEATS

Severe erosion corrosion

Auxiliary pump casing

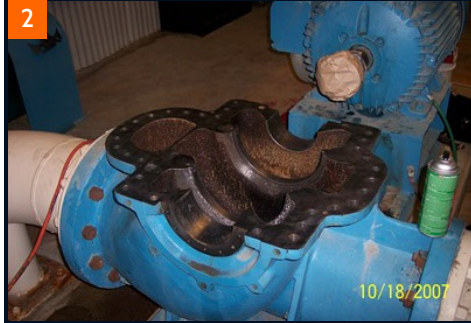
1. Pump to be rebuilt
2. Surface being prepared
3. Wear rings used as formers for Belzona 1311 rebuild
4. Scrapers used to complete application
