# DEBARKER RING PROTECTION SAVING LUMBER MILL THOUSANDS

ID: 9063

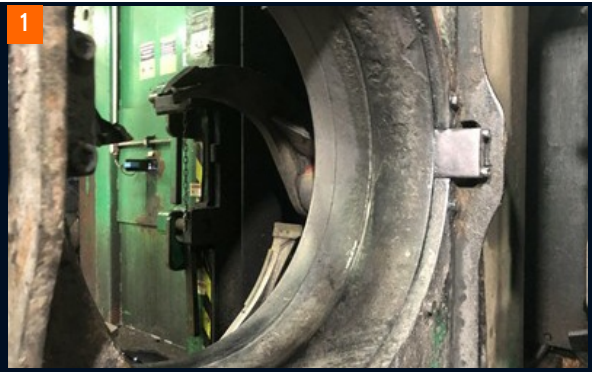
Corrosion was occurring from the salt water that enters the lumber mill from the ocean. This jeopardizes the bearing inside the ring that has a replacement cost of \$35,000.00. Protection was needing to prolong the service life of the machinery

1. Condition of Debarker ring
2. After sandblasting
3. Resurfacing with Belzona 1311
4. Coating of Belzona 1321
