# BELZONA SEALS THE EXPANSION JOINT AT THE ENTRANCE TO THE UNDERGROUND GARAGE OF A LARGE RESIDENTIAL BUILDING

ID: 9066

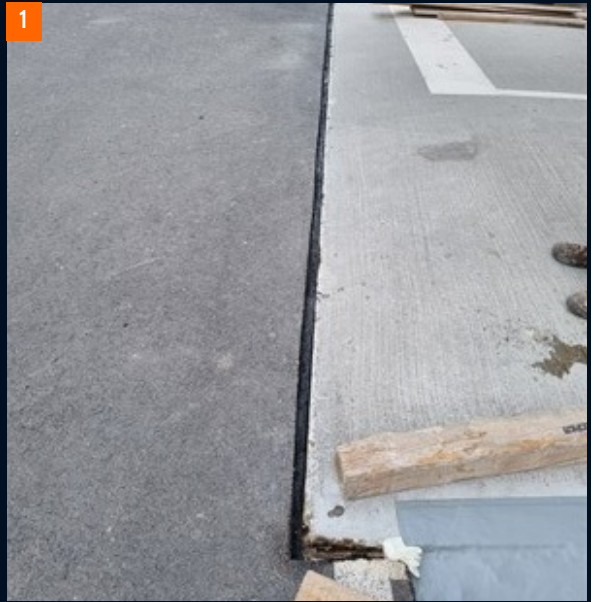
1. Expansion joint cleaned and conditioned with Belzona 4911
2. Belzona 4511 applied on sides and Belzona 4521 applied on the horizontal section of the joint.
3. Installing thick planks after the application in order to enable traffic. We used those planks also during the application.
4. Situation after 7 months, with Belzona sealants still intact and in perfect condition.

We grinded away asphalt and concrete until we reached the existing insulation beneath them. Then we thoroughly cleaned the surface and applied Belzona 4911 Conditioner. Right after that, we applied Belzona 4511 on both sides (downward slopes) and Belzona 4521 on the horizontal section. Then we protected the area of application with thick planks, so tenants could use the underground garage.
