# BELZONA UNCLOGS FOULED SCRUBBER

ID: 907

Scrubber in the cogeneration plant of a sugar refinery.

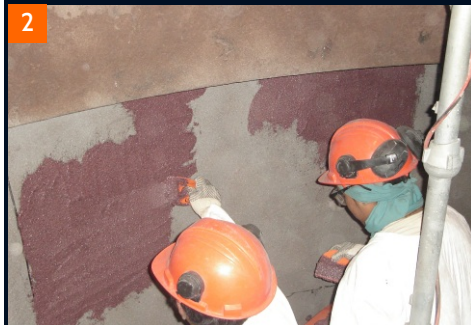
1. One of two scrubbers to be rescued with Belzona.
2. Belzona 1811 (Ceramic Carbide) was applied to high wear areas to provide extra abrasion resistance.
3. Belzona 1391 (Ceramic HT) provides a smooth surface and has the abrasion and temperature resistance required.
4. Belzona 1391 (Ceramic HT) eleven months later. Discoloration is caused by elevated temperatures but coating is 100% intact and fouling was totally eliminated.
