# BELZONA TANK BASE SEALING SEALS OUT THE WEATHER

ID: 9072

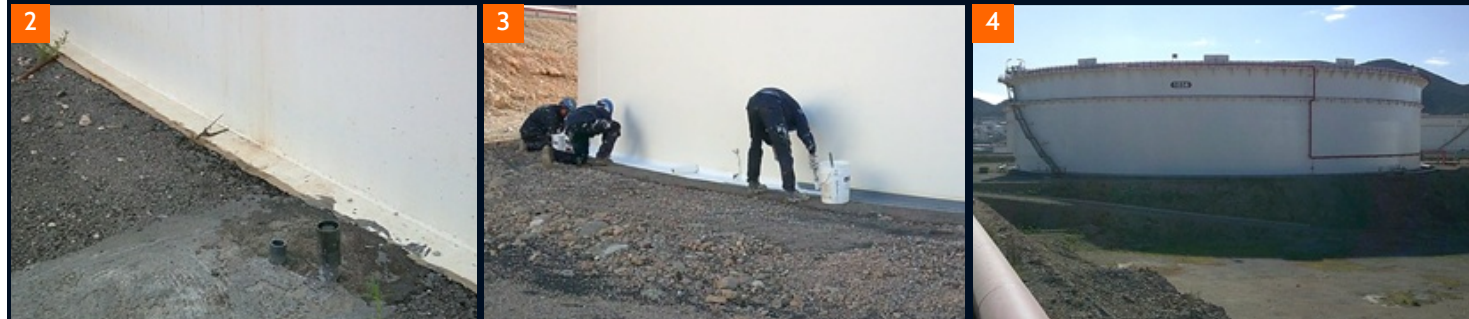
The areas round the base of the tanks were deteriorating and required protection from the elements, to prevent moisture ingress under the tanks.

1. Photo of a tank prior to application.
2. Photo of a tank prior to application.
3. Application in progress.
4. One of the tanks with the tank base sealing system installed.

Belzona 3211 was applied as per system leaflet GSS-03.

Belzona offered a solution allowing for moisture ingress to be mitigated, helping reduce any future metal loss of the tank base.
