# BELZONA PATCHES HEATED OIL JACKET

ID: 9074

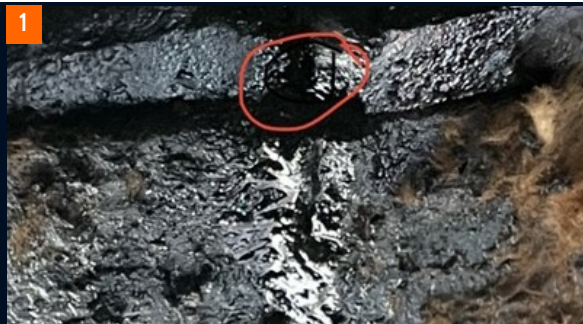
Customer had a pinhole leak in corner of heated oil jacket. It was not possible to drain this jacket as it was tied into the other 73 tanks.

1. Pinhole leak in oil jacket
2. Live leak plugged with Belzona 9611 and sealed with Belzona 1221
3. Belzona 1511 used to rebuild the area
