# BELZONA SUPERWRAP II SYSTEM SAVES 120K

ID: 9078

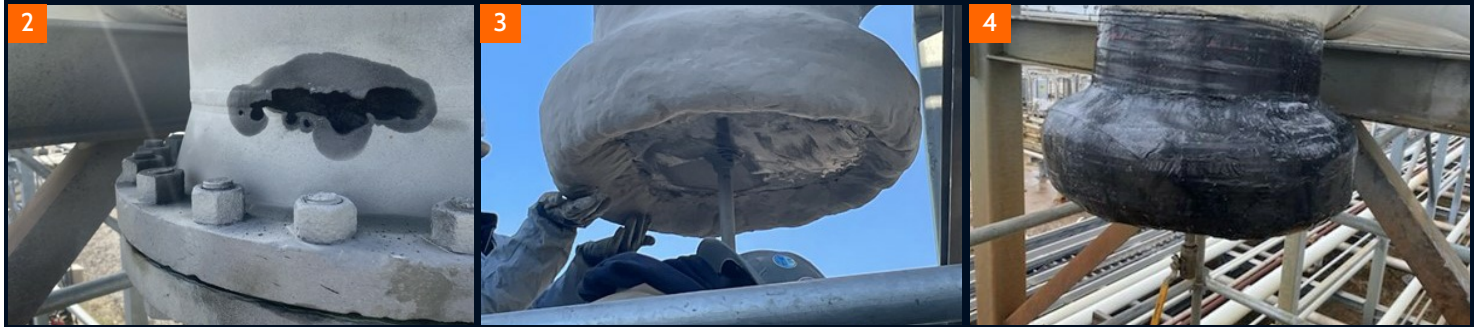
## PHOTOS

The customer had a clamp previously put on a hole in the condensate line. The clamp started leaking and they were going to replace them at this time.

1. Line clamp leaking.
2. Clamp removed and vapor blaster used.
3. Encapsulation of entire head.
4. Finalized SuperWrap II application.

Belzona 4141 was used to encapsulate the holes and then Belzona SuperWrap II system (with Belzona 1982 resin) was used to provide structural integrity to the asset.
