# LEAK REPAIR AT PICKLING LINE

ID: 9080

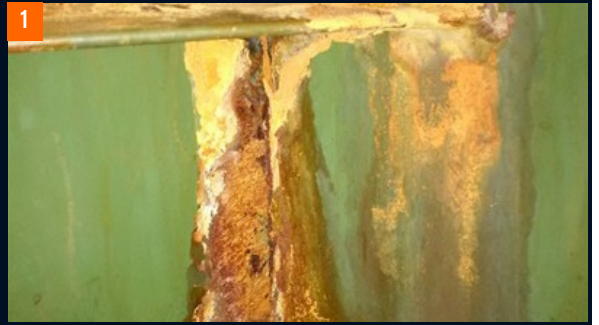
Hydrochloric acid tank in a Pickle line was suffering from chemical attack and developed a leak. They needed a product that had excellent chemical resistance against Hydrochloric acid at high concentrations to stop this leak and protect the outside of the tank.

1. The substrate chemically attacked from the acid
2. Surface preparation with a grinder to bare metal
3. Cleaned substrate before product application
4. Finished application with Belzona 1593 as top coat
