# BELZONA FORMS GASKET SURFACE ON OVER 50 YEAR OLD BOILER

ID: 9081

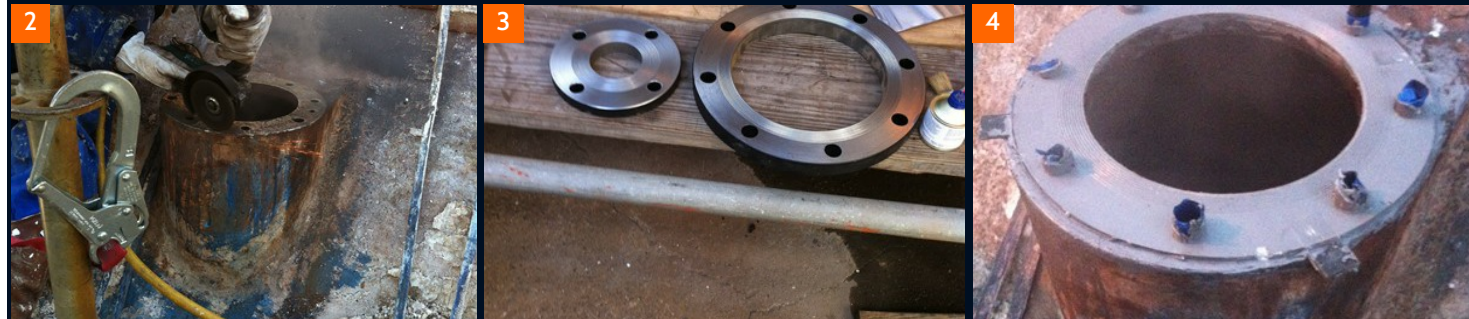
## PHOTOS

The gasket surface on the nozzle of a boiler was heavily pitted not allowing them to achieve a seal.

1. Gasket damage
2. Surfaces preparation
3. Formers used
4. Application completed

Belzona 1111 was used in conjunction with a former to restore the gasket surface to the boiler nozzle.

Hand tools were used for preparation of the surface. Belzona Release Agent was applied to the former to allow removal.
