# BELZONA PROTECTS ACID BARGE DRIP PANS

ID: 9082

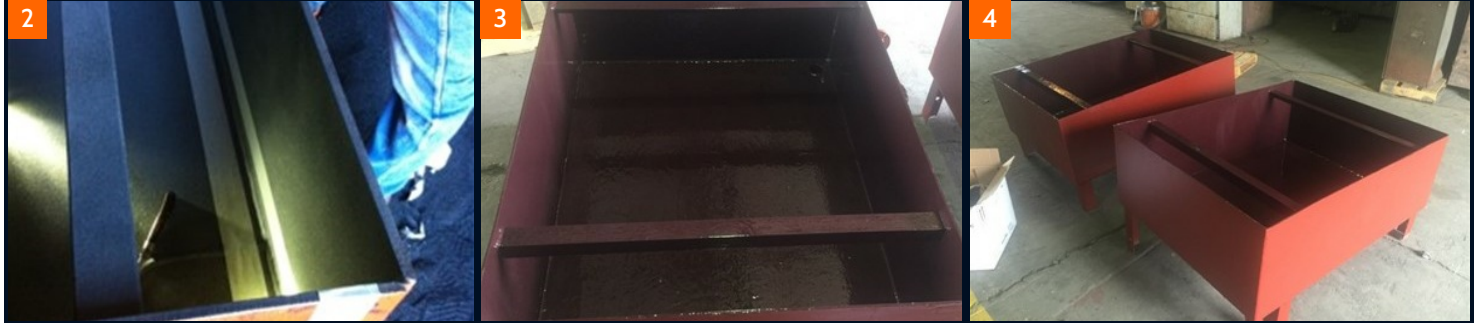
Customer was experiencing corrosion in their unlined drip pans.

Client was replacing their acid drip pans every few years. Acid remnants would sit in the pans exposed to atmosphere and corrode the bottom.

1. Surface preparation drip pan 1
2. Surface preparation drip pan 2
3. Product application process
4. Application completed.

Grit basted the interior surface. Applied 4301 to fillet the weld seams. Then applied 4311 to the entire interior.

Coating with Belzona dramatically extended the life of the pans, saving the customer money not having to replace them every few years.
