# BELZONA REPAIRS OVERHEAD CONCRETE ABOVE PEDESTRIAN WALKWAY AT LOCAL HOSPITAL

ID: 9088

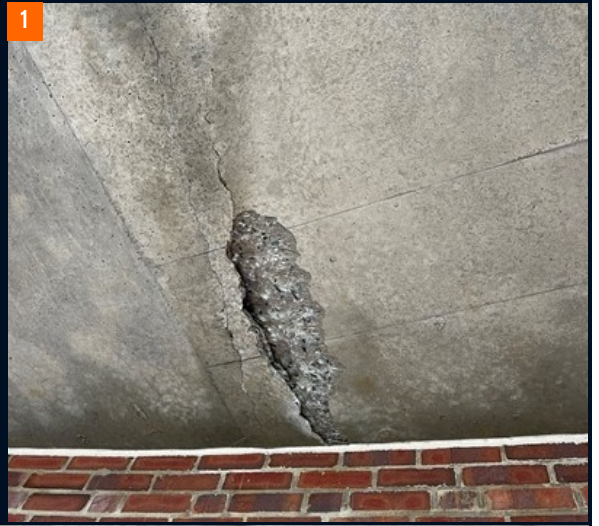
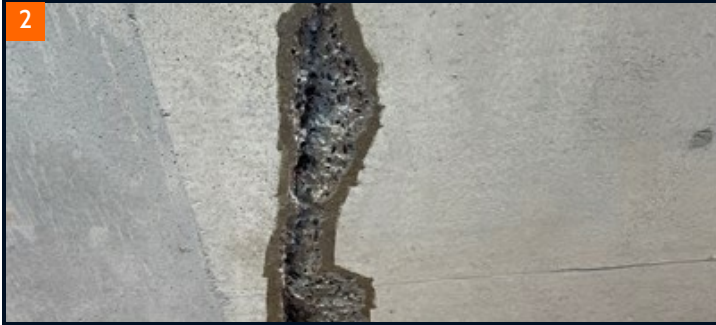
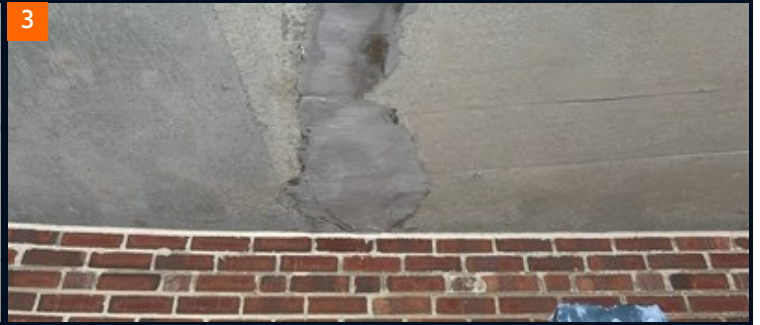
Pieces of Concrete were falling from bottom of sidewalk ramp 10 ft above pedestrian walkway

We set up safe zone and barricaded to keep pedestrians from trafficking into the work area. Plastic was put down under repair areas. We chiseled out repair areas and removed rust from any exposed rebar. We applied Belzona 4911 Conditioner first then the Belzona 4141 Concrete repair material. It was quite difficult hanging the Belzona 4141 upside down but we persevered. Would probably use some plyboards next tiime.
