# BELZONA RESTORES KITCHEN WASHROOM FLOOR

ID: 909

Hospital kitchen washroom floor

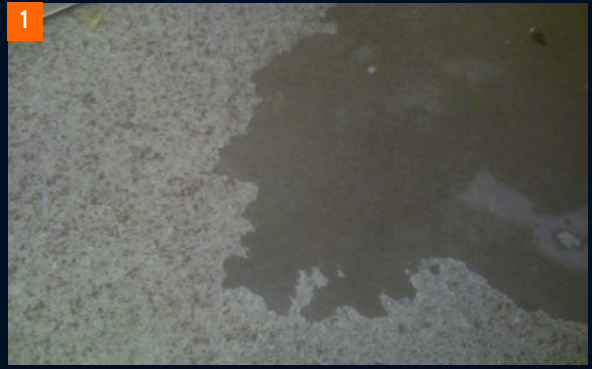
The terrazzo floor had degraded from constant cleaning and contact with cleaning solutions.

1. Close-up of original damaged floor
2. Heavy damage in washdown room
3. Finished floor where washing machine goes
4. Finished floor from outside hallway

The application was carried out in accordance with Belzona Know-How System Leaflet FPA-1. Belzona® 5231 was applied and extra grit broadcast on top.
