# BELZONA REPAIR AND PROTECTION OF PIG LAUNCHERS

ID: 91

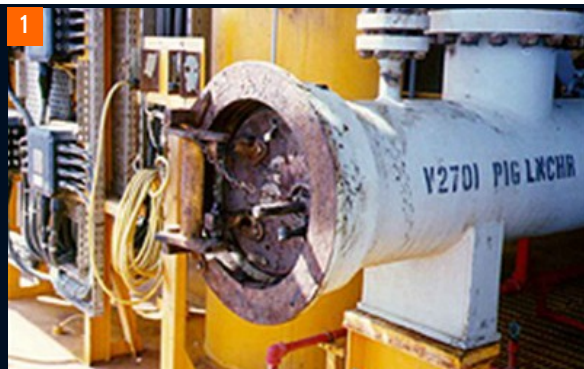
Crevice corrosion had caused pitting on the existing seal faces of pig launcher. New receivers for "Intelligent Pigs" required an impact/abrasion and corrosion resistant lining.

1. Existing pig launcher showing seal area
2. On-site machining of Belzona 1111 underway
3. Application of Belzona 1321 to a new launcher

Seal faces were rebuilt in accordance with a modified version of Belzona® Know-How Leaflet VPF-1, and machined on-site to the required tolerances. New launcher receivers were coated with Belzona® 1321 in accordance with Belzona® Know-How Leaflet VPF-2.
