# BELZONA LINING FOR HEAT EXCHANGER SUMP

ID: 911

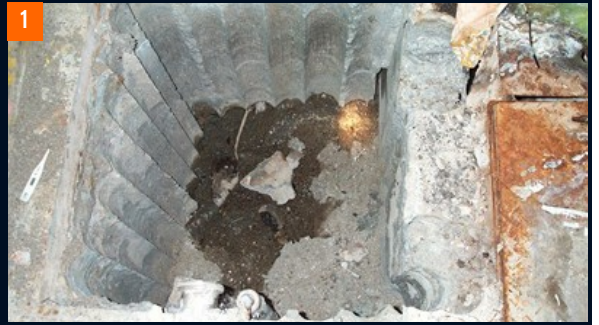
1. Sump drilled out
2. Cutting inlet and outlet channels to laundry drain
3. Walls rebuilt with Belzona 4141 and paving slab installed
4. Sump screeded with Belzona 4181

Application carried out in accordance with modified version of System Leaflet TCC-9. First a new base to the sump was created using a paving slab. Belzona® 4141 was applied to fill the damage caused by the drill cores. Belzona® 4181 was then screeded over the entire surface to provide heat resistance.
