# BELZONA REPAIRS LEAKING ELEVATOR PIT AT APARTMENT COMPLEX

ID: 9110

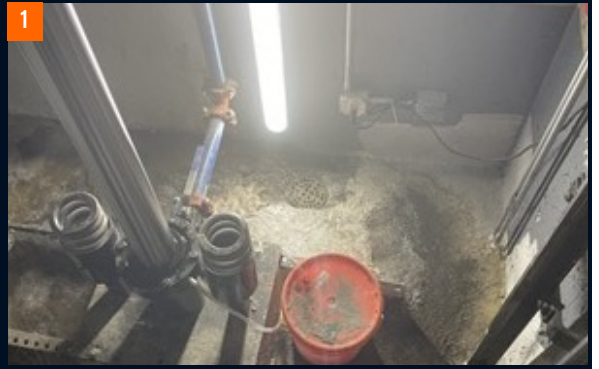
Elevator Pit was leaking really bad from around the shaft area and from under a metal plate. The pit was not passing inspection by the state of North Carolina and was going to be shut down and taken out of service. It was the only elevator in a 4 story apartment building.

1. Elevator Pit
2. Visual Damage
3. Application in progress
4. Complete application
