# BELZONA 1818 PROTECTS SHAFT FROM ABRASION

ID: 9114

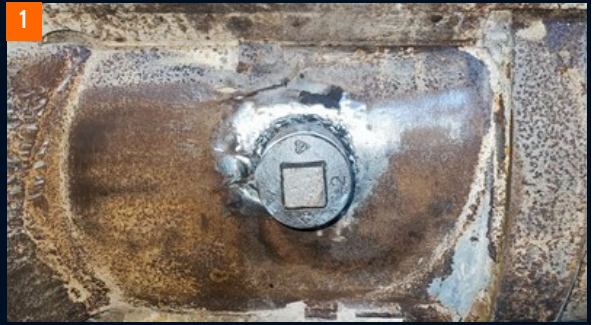
1. Area prepared using a power tool (MBX Bristle Blaster)
2. Belzona 1818 applied
3. Belzona 1818 applied
4. Belzona 1818 after 15 months in service

The areas where Belzona 1818 was to be applied were prepared using an MBX Bristle Blaster.
