# BELZONA PROVIDES CAVITATION REPAIR AND PROTECTION FOR A LARGE HYDROPOWER UNIT IMPELLER

ID: 9115

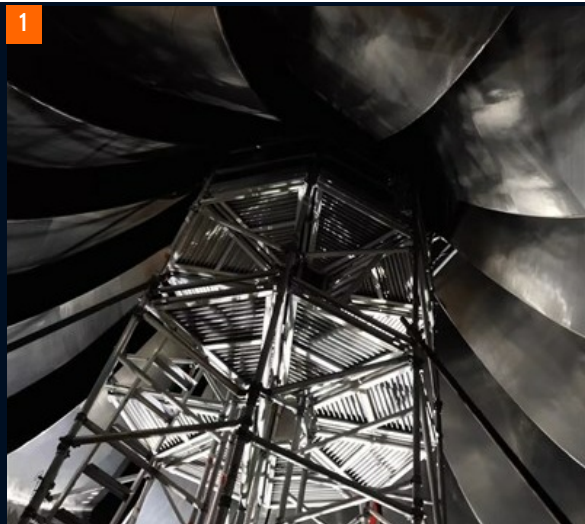
Cavitation occurs at the top of Francis impeller in a hydropower station unit

The impellers have been affected by cavitation for many years. In the past, they were repaired by welding every two years. After a period of time, cavitation occurred again. This caused repeated deformation of the impellers, resulting in power generation efficiency decrease and increasing maintenance frequency and maintenance time. One year after the application of Belzona 2141, the impellers have been checked and witnessed few cavitation of Belzona 2141. Overall, the impellers were well protected and clients were satisfied.

1. the image of affected impeller
2. Pitting corrosion before repair
3. the surface after Belzona 1341 application
4. application completed

The application was carried out in strict accordance with Belzona Know How leaflets FBC-1 and FBC-2. Belzona 1311 was used to repair the cavitation areas after grit blasting. Then, applied two coats of Belzona 1341 to improve fluid efficiency for the equipment. Finally, Belzona 2941 and Belzona 2141 were applied to protect the outer surface against cavitation and corrosion.
