# BELZONA PROTECTS A SCREW CONVEYOR WITHIN A PETROCHEMICAL REFINERIES' WASTEWATER FACILITY.

ID: 9117

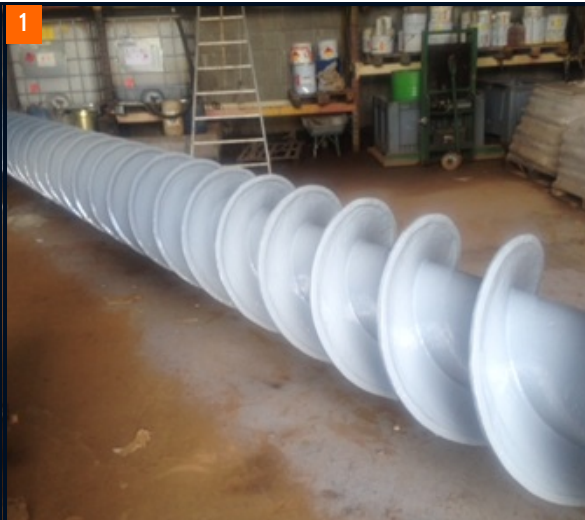
1. Screw during the Belzona 1341 application.
2. Screw & trough once completed.
3. Screw & trough once put back into service.

The screw trough was coated using Belzona 5811, an immersion-grade epoxy barrier coating, prior to being overcoated by black paint for aesthetics. The screw was also coated with an epoxy coating Belzona 1341, however, the latter is designed to increase the efficiency and reduce waste material drag. The application was carried out in accordance with Belzona System Leaflet SMH-14.
