# REPAIR AND PROTECTION OF BRINE WATER VERTICAL PUMP

ID: 9126

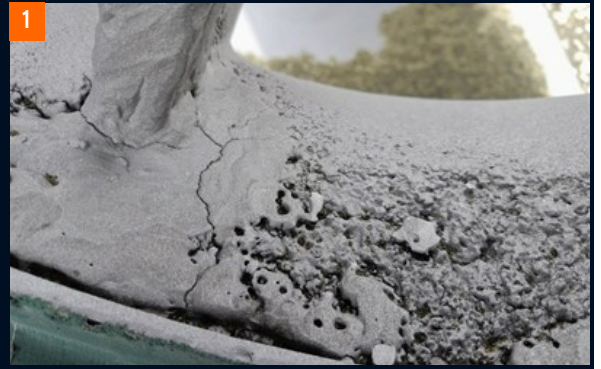
The pump casing was suffering from erosion and corrosion due to the salt water medium. The pump internal body was pitted and the external body was suffering from general corrosion. The customer requested a solution that would restore the pump's original profile and protect it for years to come.

1. Before application: internal pitting damage
2. Before application: external corrosion
3. After application: internal surface coated for protection
4. After application: external surface coated for protection

The pump components were entirely blasted to reach the Belzona recommended 75 micron profile and salt tested to ensure that salt levels were minimal. Following surface preparation, Belzona 1111 was mixed according to the IFU to pit fill the damaged surfaces. After curing, the surface of Belzona 1111 was sweep blasted to receive protective coatings. Two coats of Belzona 1341 were applied internally and two coats of Belzona 5811 were applied externally at the recommended thicknesses indicated in the IFU.
