# GROUTING AND FAIRING OF BASALT TILES IN A CEMENT SEPARATOR WITH BELZONA

ID: 9129

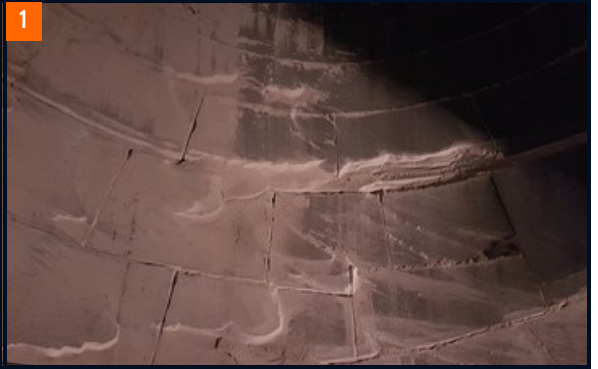
A separator in a cement plant is clad with basalt tiles, which are exposed to severe abrasion and they need to be protected from further deterioration.

A Humboldt-type separator operates in a cement plant 24/7. It is clad with basalt tiles, which are good and long-term solution, but eventually they get worn by severe abrasive influence of cement particles that are travelling through the separator in a turbulent flow. Customer allows a 5-day window to perform works inside the separator, during the annual turnaround and was looking for a solution that can solve the problem within selected timeframe.

1. Damaged basalt lining within the separator
2. Preparation for work inside the separator
3. Belzona 1812 applied
4. Situation after 18 months – still OK

Application was carried out in accordance with Belzona Know-How System Leaflet SHM-7. Surfaces were dedusted with vacuum cleaner, then abraded with grinders and cleaned with acetone. Belzona 1812 was applied to damaged areas of tiles and joints with Belzona application tools.
