# BELZONA PROTECTS A COAL PULVERIZER WHEEL BRACKET

ID: 913

Coal pulverizer wheel bracket.

San Miguel Power Project Christine, TX

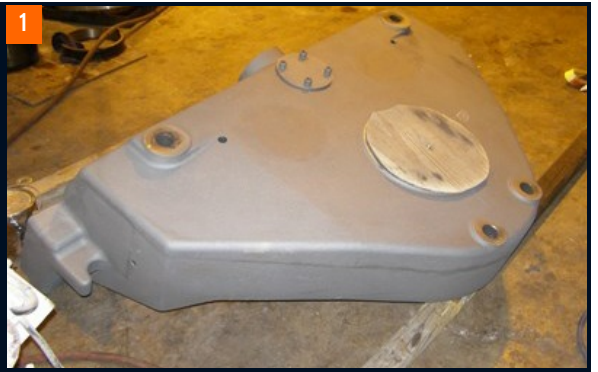
1. New pulverizer wheel bracket prepared for application
2. Belzona 1812 being applied
3. Completed application
