# BELZONA PROTECTS CONTAINMENT AREA

ID: 914

Containment area for water treatment chemicals.

Power Project - Bastrop, Texas, USA

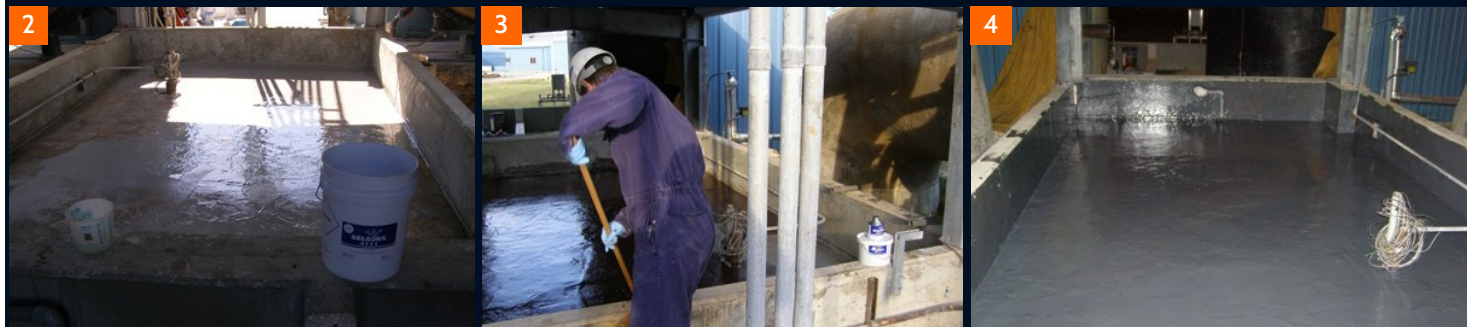
The previous coating had failed causing significant damage to the underlying concrete.

1. Containment area prior to being coated
2. Area prepared and leveled with Belzona 4111
3. First coat of Belzona 4311 being applied
4. Completed application

The application was carried out in accordance with Belzona System Leaflets TCC-9 & 15

Previous attempts to coat this area had failed due to the chemical concentration. Belzona was chosen for its high chemical resistance. The two color system was also seen as an advantage as it will show when the coating needs to be touched up.

Belzona 4111 (Magma Quartz)  
Belzona 4311 (Magma CR1)
