# BUND COVER PLATES RECEIVE BELZONA ACID PROTECTION

ID: 9142

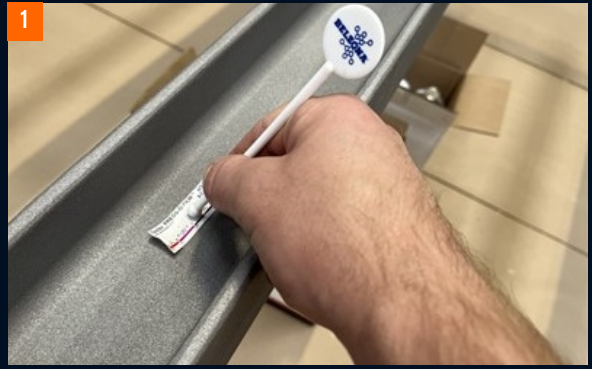
1. Blasted to SA 2.5 and 75 microns minimum
2. Belzona 4351 (Magma CR5) applied to supporting beams
3. Cover plates prepared as per Belzona 4351 (Magma CR5) IFU
4. All steel work protection completed.

Grit blasting carried out in our internal Blast-booth to SA2.5 and 75 microns (minimum)
