# BELZONA SAVES BOW THRUSTER FROM GOING UNDER

ID: 9143

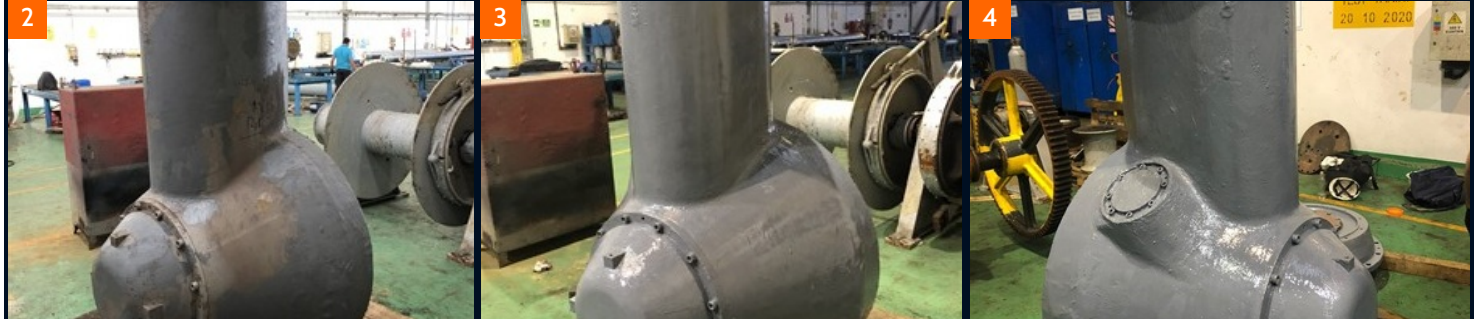
## PHOTOS

There was severe cavitation and corrosion damage on the surface of this bow thruster

1. Before Application (showing the cavitation damaged areas)
2. Belzona 1311 Applied for Repair
3. Belzona 1321 First Layer Coating Applied
4. Belzona 1321 Second Layer Coating Applied

The surface of the bow thruster was first washed down with Belzona 9111 (Cleaner Degreaser) to remove all the dirt, grease and other surface contaminants before being grit blasted. Then Belzona 1311 (Ceramic-R-Metal) was used to repair the bow thruster, before adding a final coats of Belzona 1321 (Ceramic-S-Metal) to protect the equipment from further damage.
