# BELZONA RELIEF VALVE REPAIR

ID: 915

Hydro Electric Generating Station - Scotland

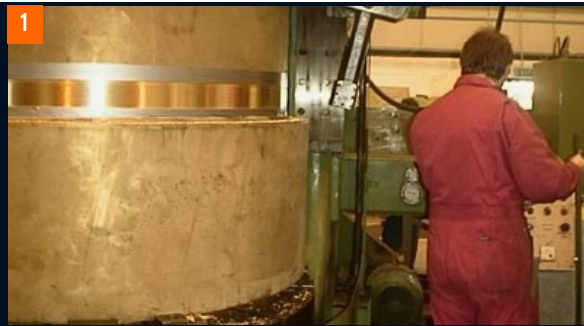
The sealing surface on the pressure relief valve had suffered damage and water was passing causing the valve not function properly.

1. Piston being machined out.
2. Belzona 1111 machined to tolerance.
3. Valve in for overhaul in 2007. This had nothing to do with the original Belzona repair.
4. Belzona in good condition and was returned to service with no work required after passing offsite hydrostatic testing and onsite commissioning.

Application was carried out in accordance with the Belzona Know-How System Leaflet MPT-1. Damaged area was machined out, filled with Belzona® 1111 then machined to tolerance.

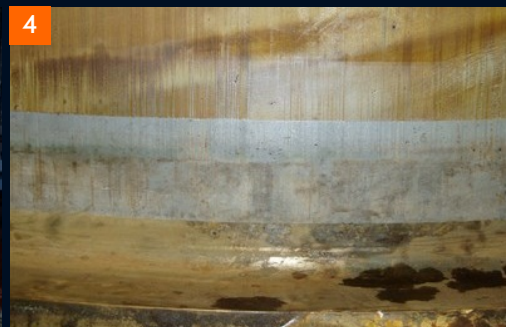
The difficulty of weld repairing similar jobs previously had led to lost time and missed deadlines. Written report received from client confirming Belzona repair in good condition and suitable for return to service after already completing 9 years service.
