# COOLING WATER PUMP PROTECTION

ID: 9154

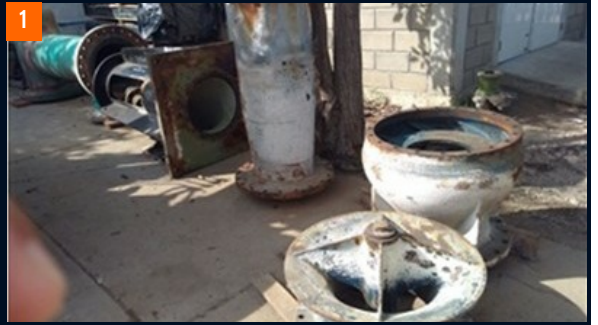
The customer performed a plant shutdown and within the schedule was the preventive maintenance of the pump in which damage to the internal coating was evidenced and they decided to replace it.

1. Complete view of the pump.
2. First beige layer.
3. Second gray layer.

It was protected with Belzona 5821 based on the CEP-3 know how system.
