# EXTERNAL REBUILDING AND PROTECTION WITH BELZONA

ID: 9155

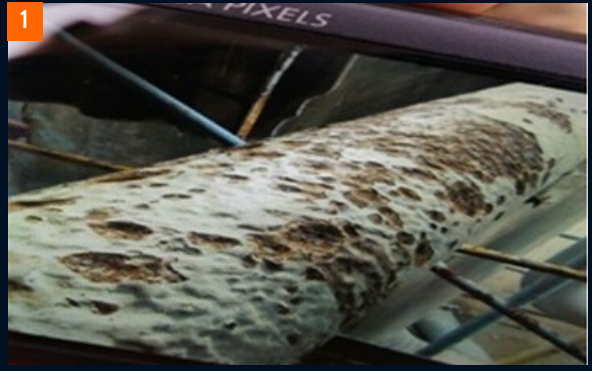
Severe corrosion on the outside of the 6" inch pipe, pitting is evident.

1. Pitting on pipe
2. First layer of Belzona 1161 and reinforcement mesh.
3. Work completed.
