# BUTTERFLY VALVE REBUILDING

ID: 9157

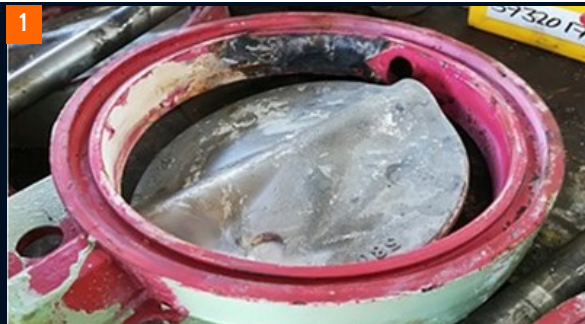
The sealing rubber was broken, which causes water to come into direct contact, eroding the substrate where the seal is made.

1. View of valve damage.
2. Demolding of neoprene strips
3. Final finishing.
