# BELZONA REPAIRS AND PROTECTS WATER TREATMENT PLANT

ID: 916

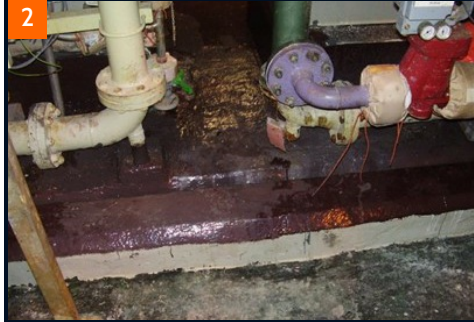
1. Substrate rebuilt using Belzona 4131
2. Protection provided by Belzona 4311 coating
3. Channels rebuilt and lined with Belzona 4181
4. Completed application back in service
