# BELZONA DELIVERS ON AWKWARD ROOF

ID: 9171

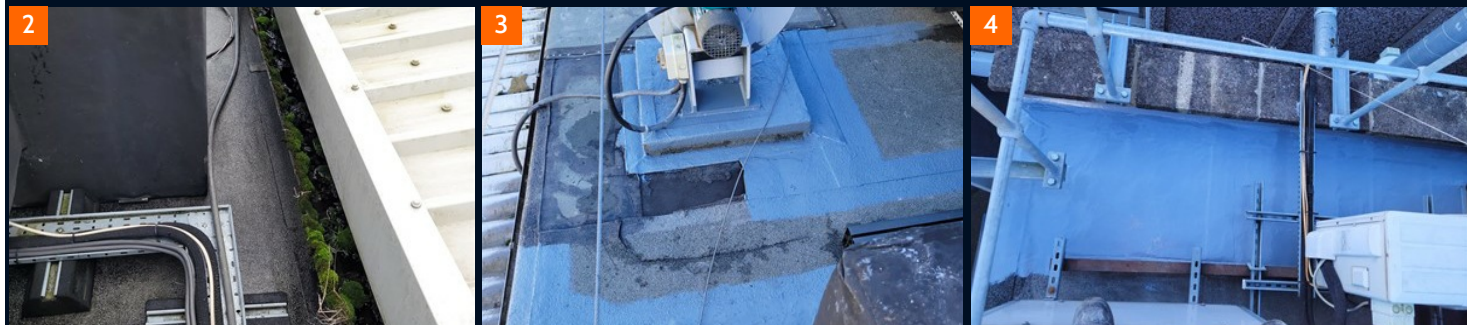
1. Bolted assets and standing water
2. Narrow access, making traditional methods almost impossible to employ
3. Geometric challenges overcome using Belzona 3000 series
4. Fully encapsulated in a short time with little difficulty

The roof was thoroughly cleaned prior to applying conditioner to some areas. After this, 2 x coats of the Belzona 3131 (WG membrane), along with the appropriate Belzona 9351 (Reinforcing Tape).
