# BELZONA SAVES RARE WINDMILL

ID: 9174

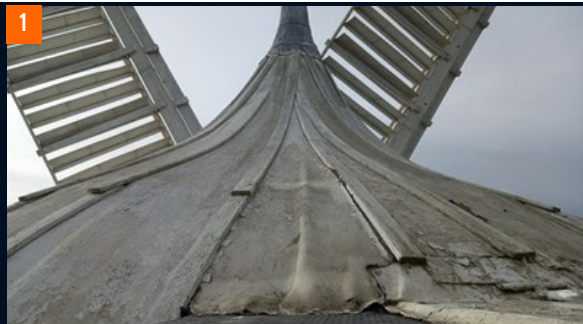
The cap of a rare windmill needed serious attention as the coating and protective material had degraded from the twin Larch skin. It was of paramount importance to rescue the windmill from any further trauma as it is the last stone bodied, 6 sail working windmill in the Country. The Cap and fan tail needed serious protection following repairs to the larch substrate as part of a refurbishment to this iconic working windmill

1. Close up of the condition of the cap, prior to restoration works
2. Lifting the cap from the structure
3. Work about to commence
4. Back to it's former glory

The old coatings and protective materials were removed and any necessary repairs were made to the Larch Substrate.. Belzona 3921 (GSC Surface Conditioner) was used prior to the Belzona 3111 (Flexible Membrane), which was reinforced by a selection of Belzona 9311 (Reinforcement Sheet) and Belzona 9431 (Reinforcement Tape). The cap was re-lifted back into position prior to the sails being re-bolted. The Windmill now looks fantastic and is well protected against the elements, in the exposed hills of Southern Derbyshire

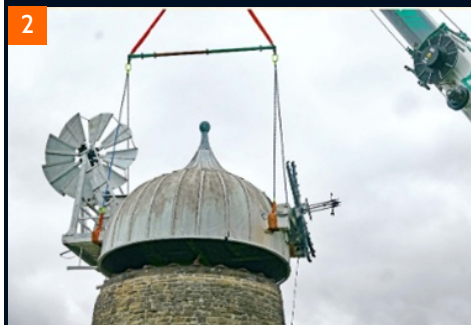
The cap had to be removed from the structure and placed on the ground so it could be worked on. The Millwright who oversaw the project specifically asked Belzona for a solution, having had conversations with other Millwrights in the UK. He had also had some experience of Belzona on another project.
